# PROGRESS IN **DISASTER** SCIENCE

NEPAL'S POST  
**EARTHQUAKE**  
**RECONSTRUCTION**  
AND **RECOVERY**  
SPECIAL ISSUE

| 7. Retrofitting of an RC frame building damaged in "April 2015 Gorkha earthquake" in Kathmandu valley<br><i>Nima Sthapit*, Nisha Sthapit</i> | 83 |

## Structural condition assessment and retrofitting of Shital Niwas building (presidential palace)

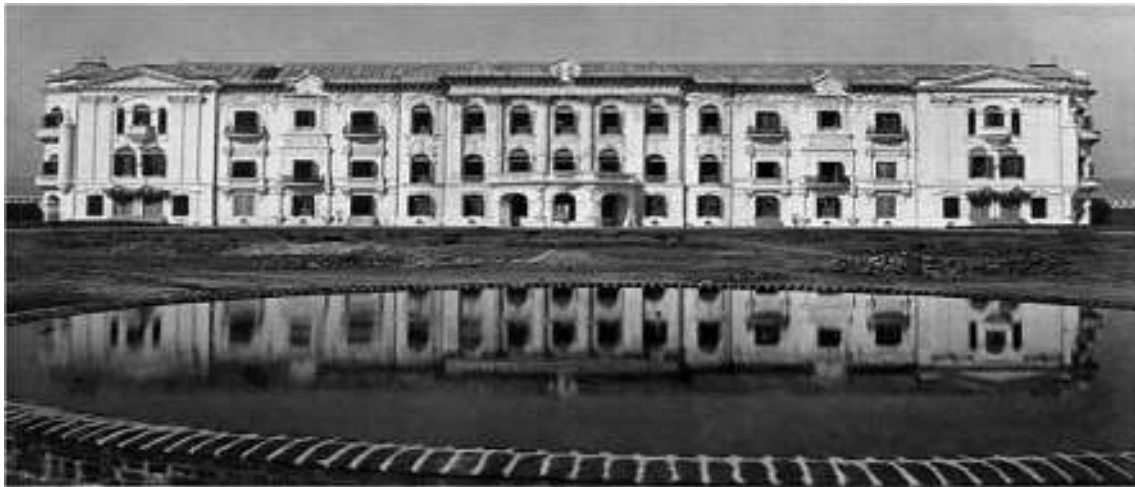
Fig. 3. East elevation of Shital Niwas before 1934 CE Earthquake (Source: Nepal Archives, DOA).

The building survived the 1934 CE Nepal-Bihar earthquake [2], even with severe damage to the eastern and southern blocks, and the 2015 Gorkha earthquake of Nepal [3] with some localized damages only on the western side. Photographs taken in the aftermath of the great 1934 earthquake by Brahma Shumsher [2], retrieved from the National Archive of Nepal, suggest that the damage prompted major rehabilitation of the Shital Niwas. Subsequent occupants made significant structural as well as architectural changes to the building, as is evident from the eastside facade (see Figs. 1 & 3).

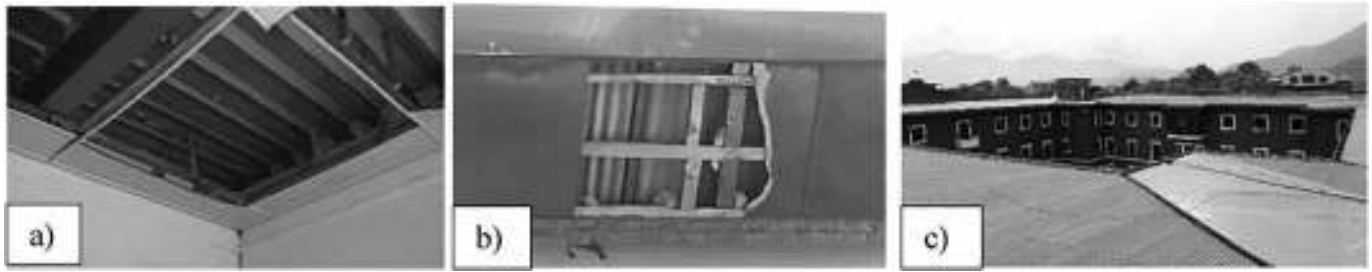
Fig. 8. Roofing Details: a) Purlins and rafters b) False ceiling, battens and CGI sheet from bottom c) CGI sheet from top.

are used (Fig. 8). The roofing system was assessed to evaluate the damaged rafters and CGI sheet for replacement.

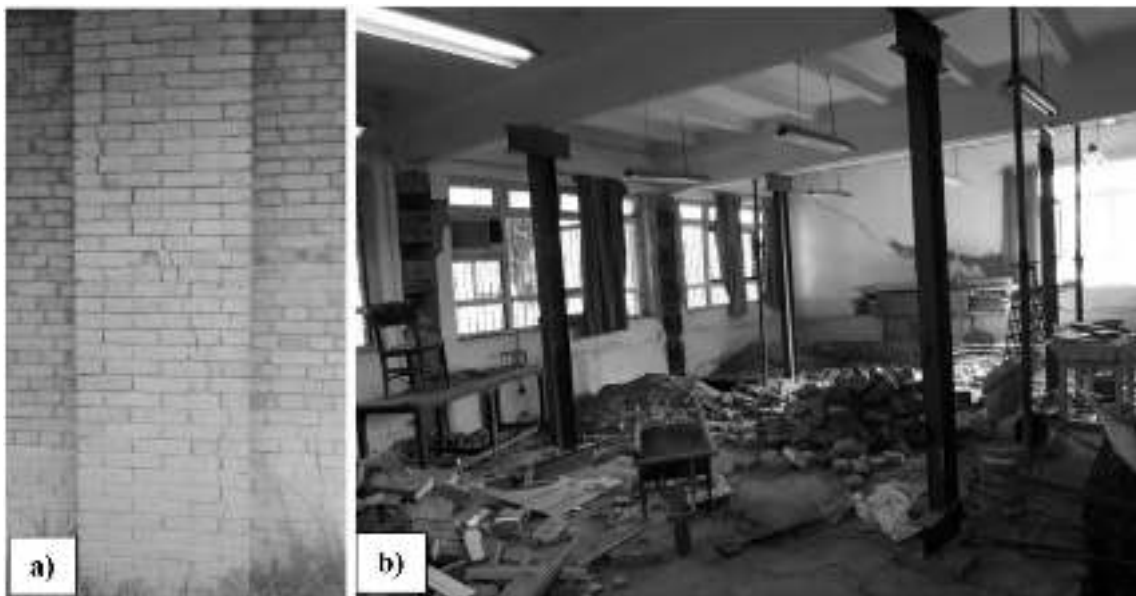
Fig. 4. a) Brick cracking in compression and shear in the pier b) View of precast beams which are directly resting over brick piers and precast slab panels resting on beams.

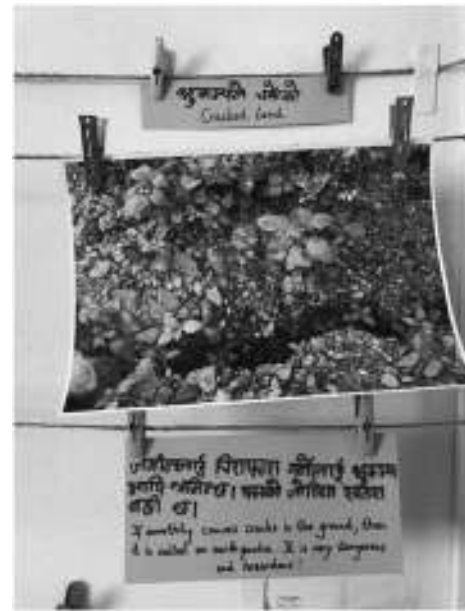
Fig. 8. Cracked land in Thapatol, Rasuwa 2018.

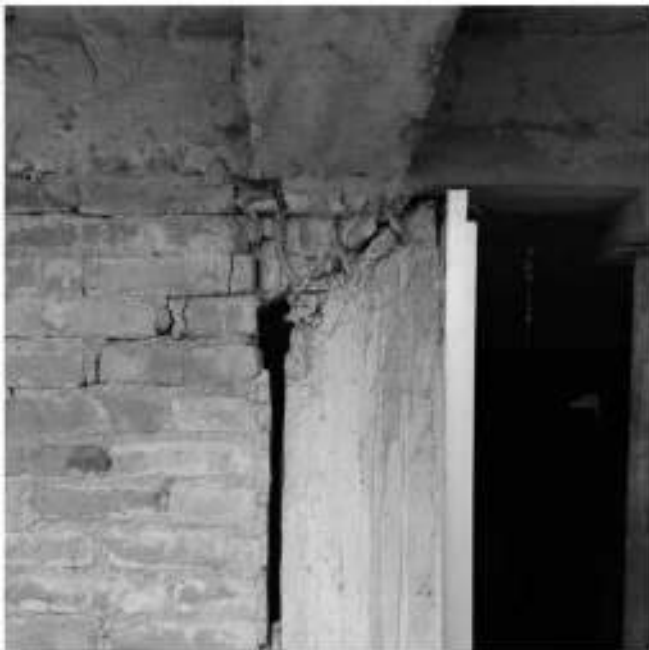
Fig. 4. Shear failure of column.

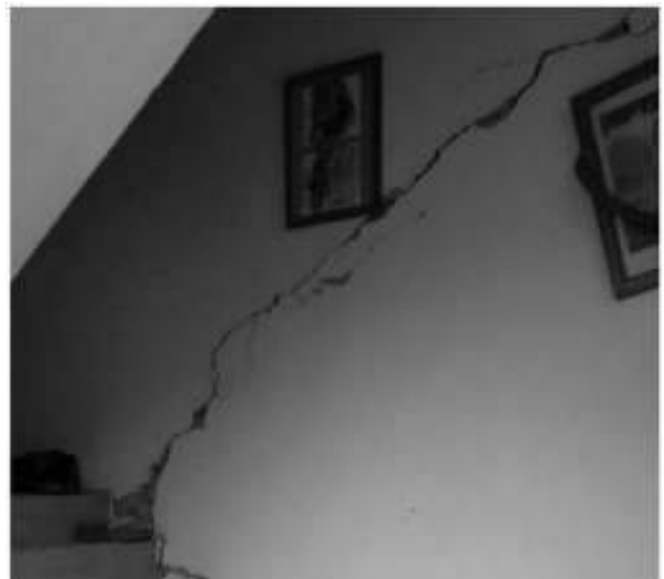
Fig. 5. Diagonal crack in staircase wall.

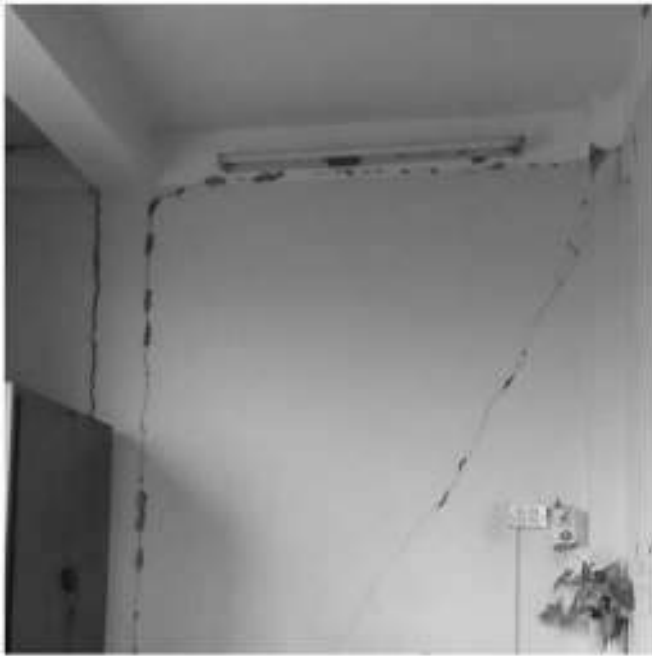
Fig. 6. Cracks in wall column interface.

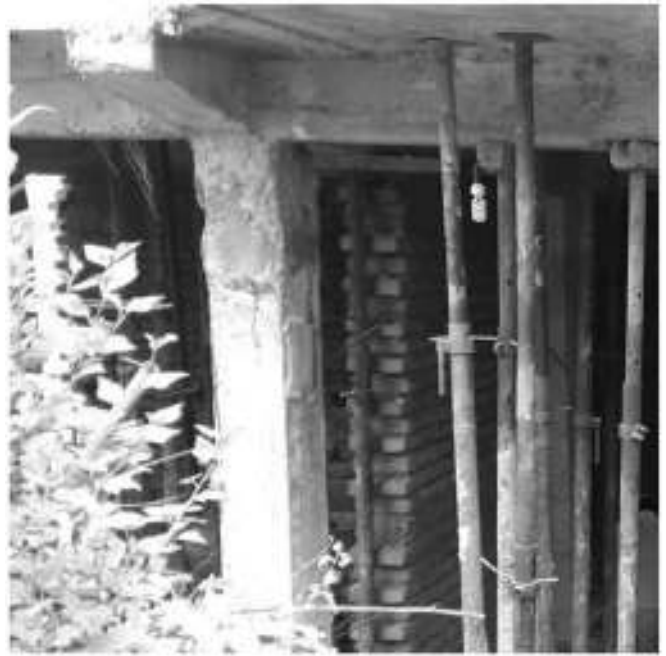
Fig. 8. Epoxy grouting and support at column 2A.

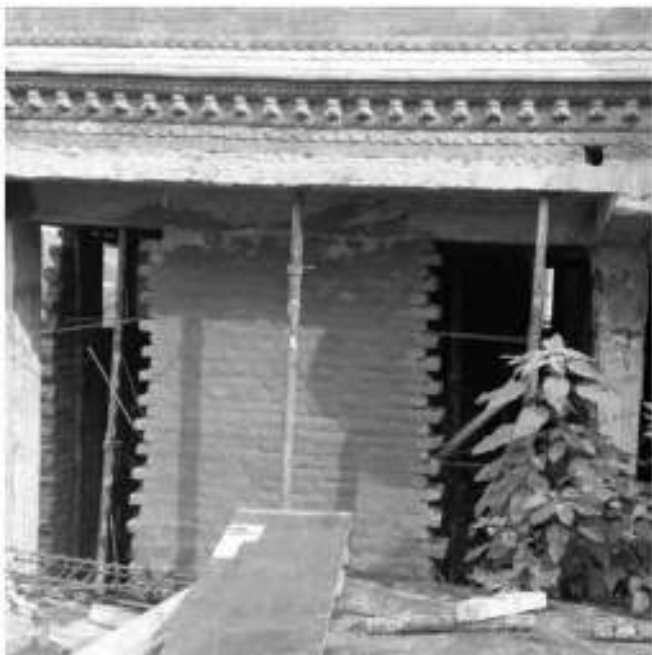
Fig. 11. Brick wall under the beams.

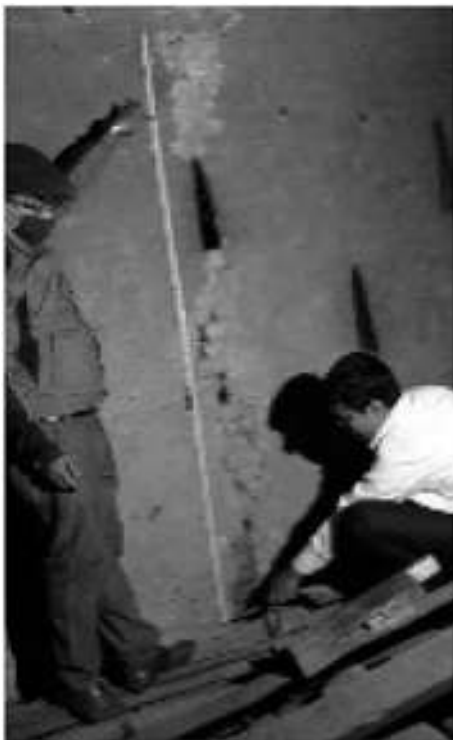
Fig. 20. Cracks in second floor.

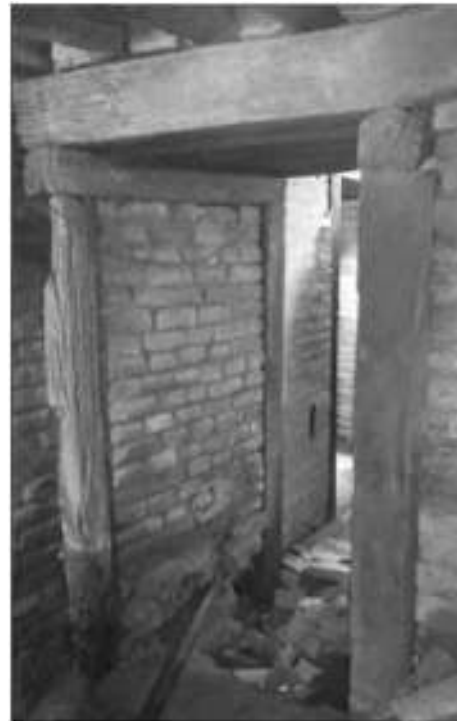
Fig. 21. Decayed posts of ground floor.

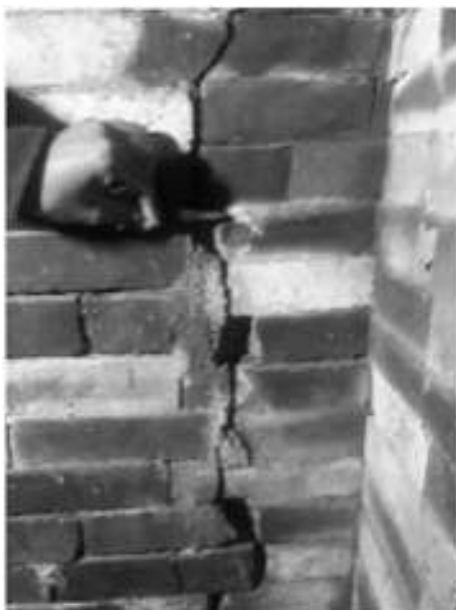
Fig. 25. Cracks in internal walls of ground floor.

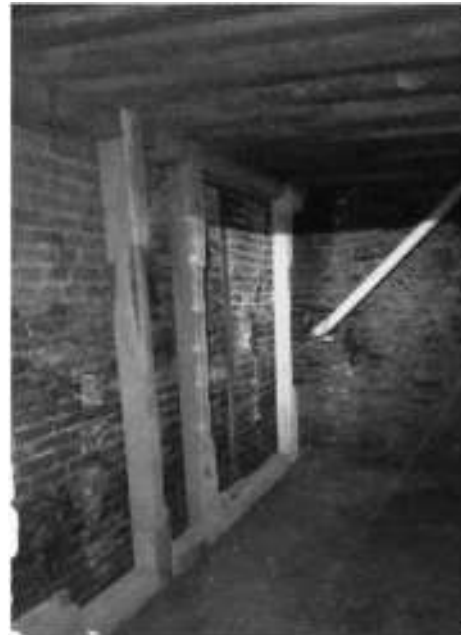
Fig. 32. Strengthening of structure in ground floor.
