NEPAL'S POST EARTHQUAKE RECOVERY & RECONSTRUCTION

NEPAL'S POST EARTHQUAKE RECOVERY & RECONSTRUCTION  
SPECIAL ISSUE

A JOURNAL OF DEVELOPMENT

VOL II • AUGUST 2021

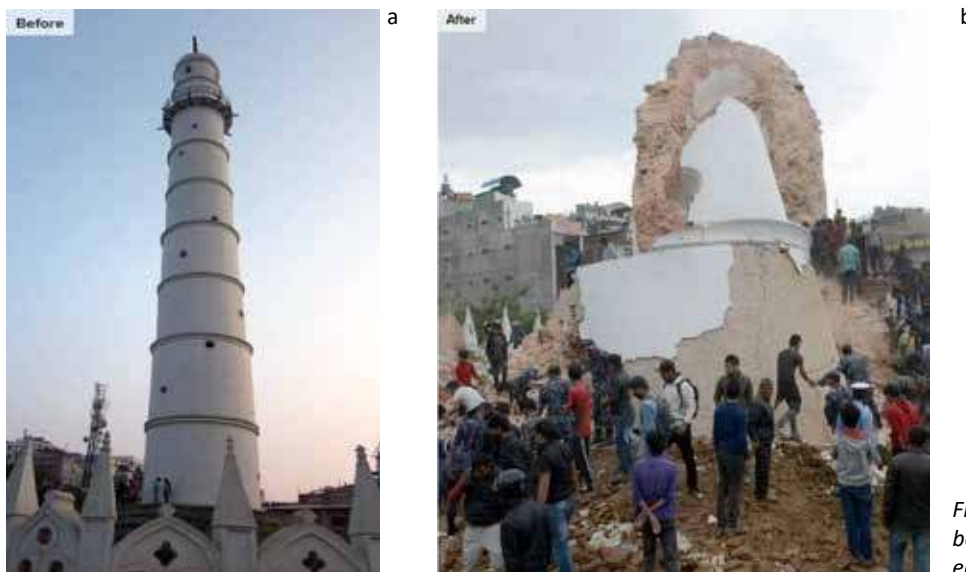
Figure 1. Photo of Dharahara before (a) and after (b) the earthquake.

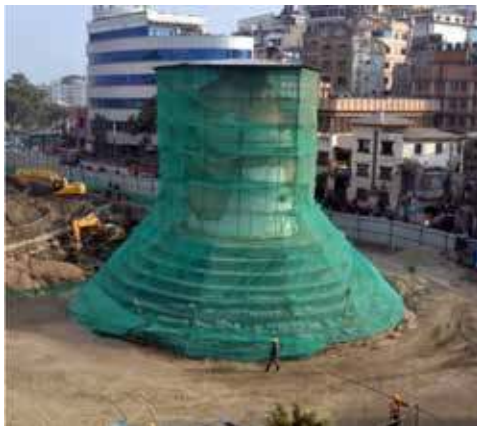
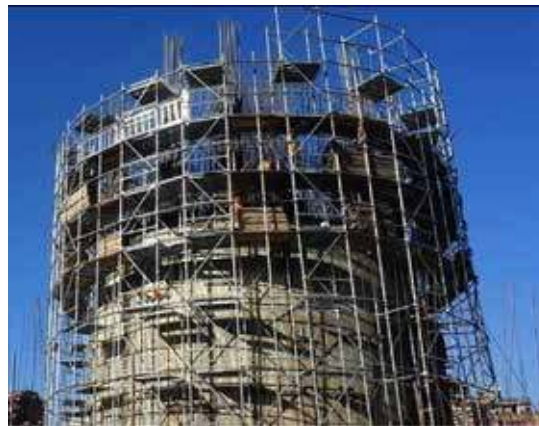
a. Preservation of collapsed "Dharahara"  
b. New construction of "Dharahara"

Following the completion of structural design and approval by competent authorities, the construction of Dharahara started in 2017 (Figure 3). To keep the legacy of the old Dharahara, its remaining part has been preserved (Figure 3a), which will be covered by protective glass enclosure. Figure 3b shows a photograph of Dharahara under construction.

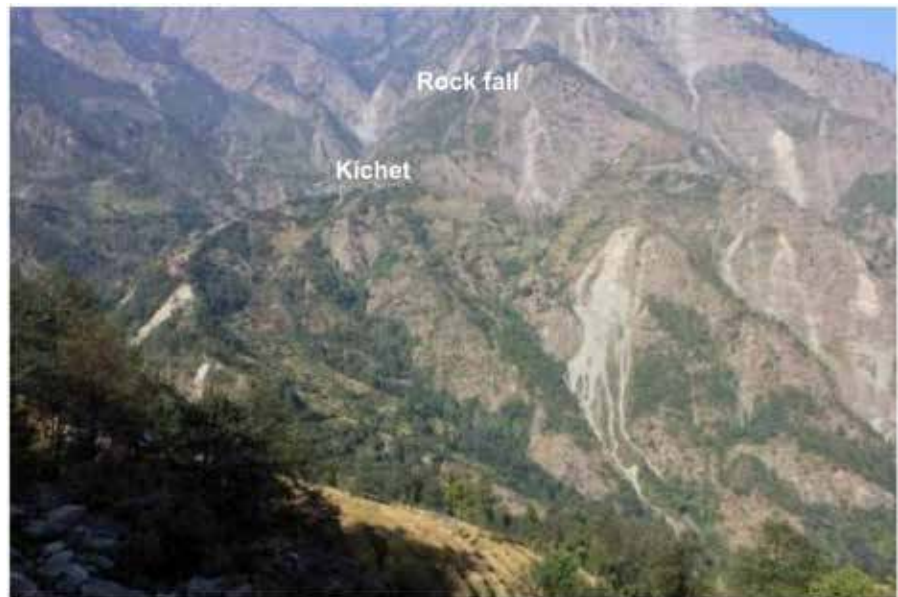
Figure 10: In the vicinity of Kichet, many shallow slides and falls occur on steep rocky slopes. View to NW

slides, and rock falls affect the slopes around Kichet (Figure 10).

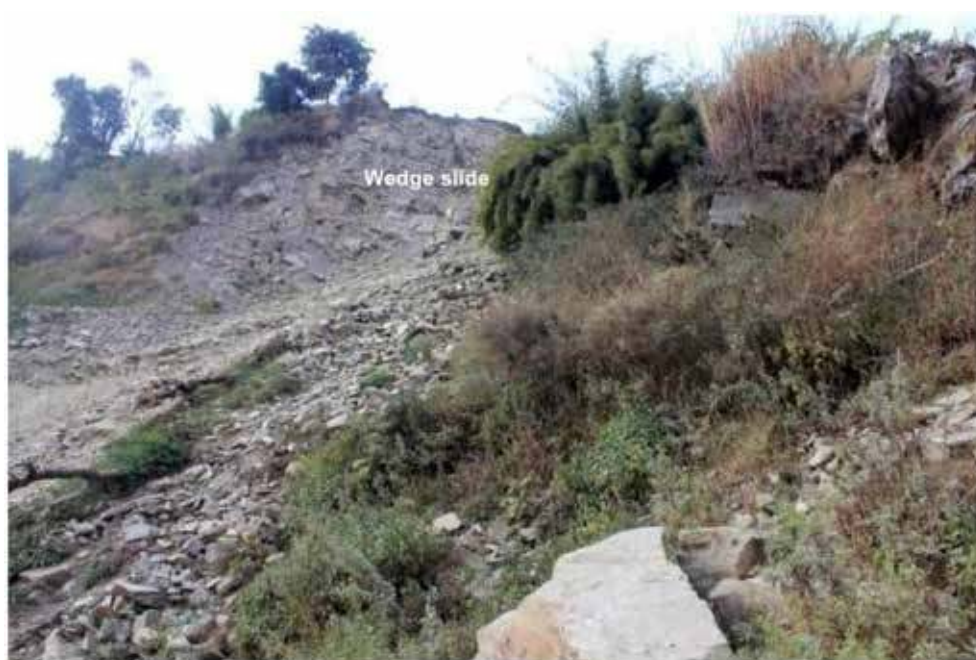
*Figure 11: A large wedge slide at Gangmrang. View to NW*

A large rockslide devastated Gangmrang, where many tension cracks are seen in the trail below the abandoned village. The failure propagated towards the village as a wedge slide (Figure 11).

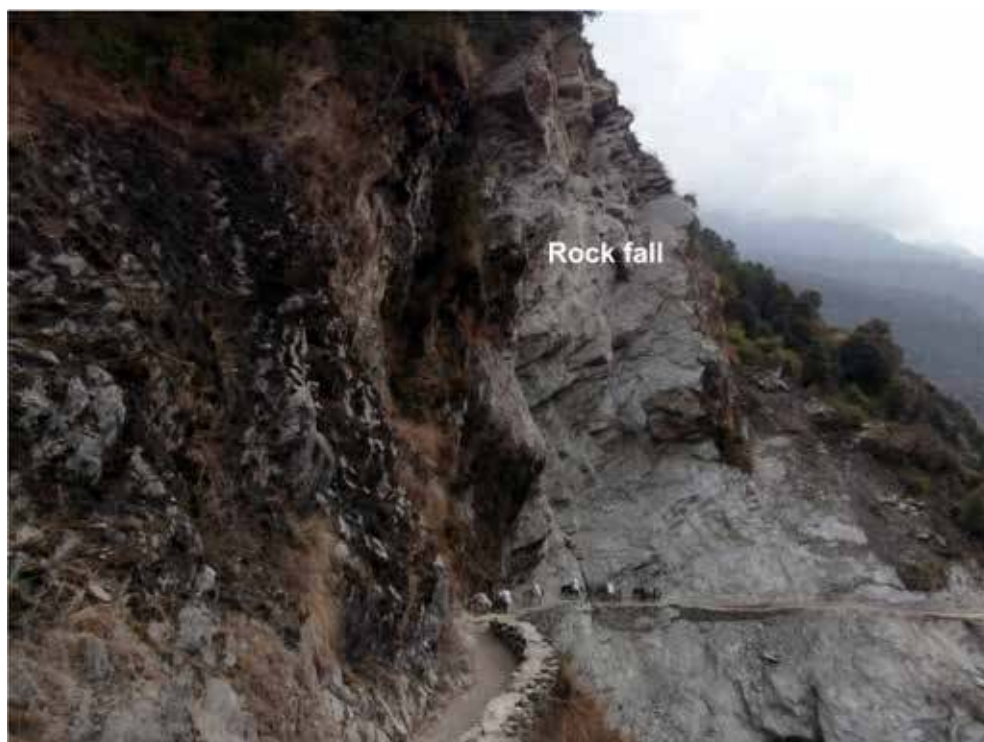
Figure 12: Rock fall affecting the trail above Gobregaun

The Borang–Sertung trail crosses about 30 m long and 20 m wide rock fall with a failed slope of about 80° (Figure 12). The failure occupies the west-facing upper slope of Gobregaun. Its runout debris has travelled for more than 300 m and can even reach a distance of 1000 m.

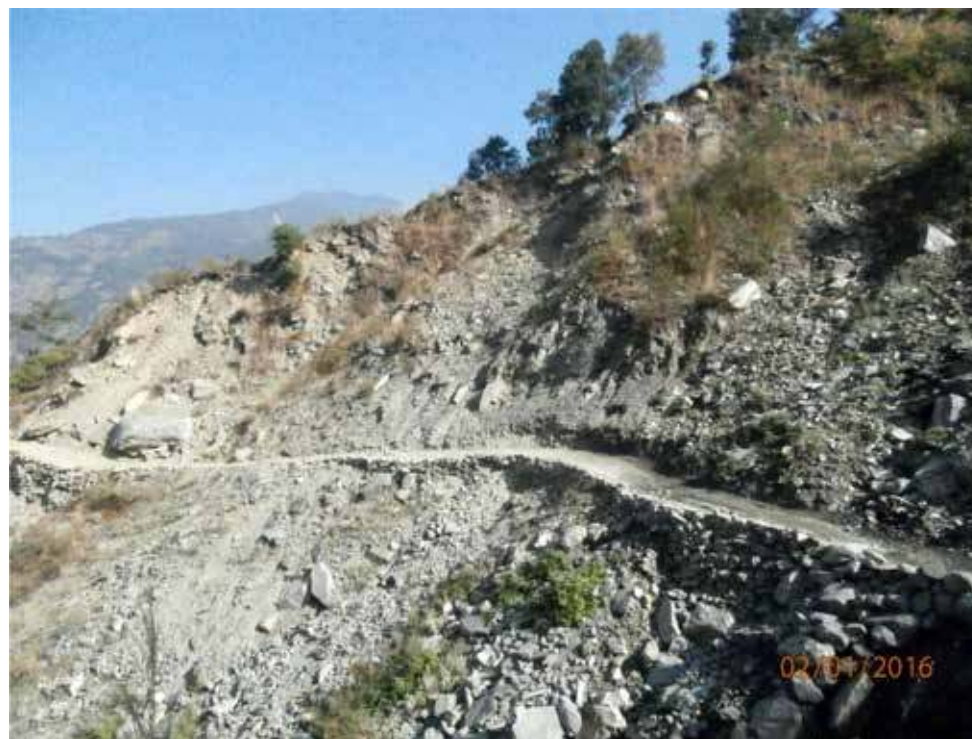
*Figure 14: Dharna colluvial slide affecting Dundure–Dhading Bensi road*

At Dharna, about 150 m long and 50 m wide, an old reactivated rock fall – rockslide contains large (up to 1.5 m) blocks and the debris has travelled for about 500 m to the river. A road passes through the middle of the slide. The landslide is saturated with water, as a stream is flowing through it (Figure 14).

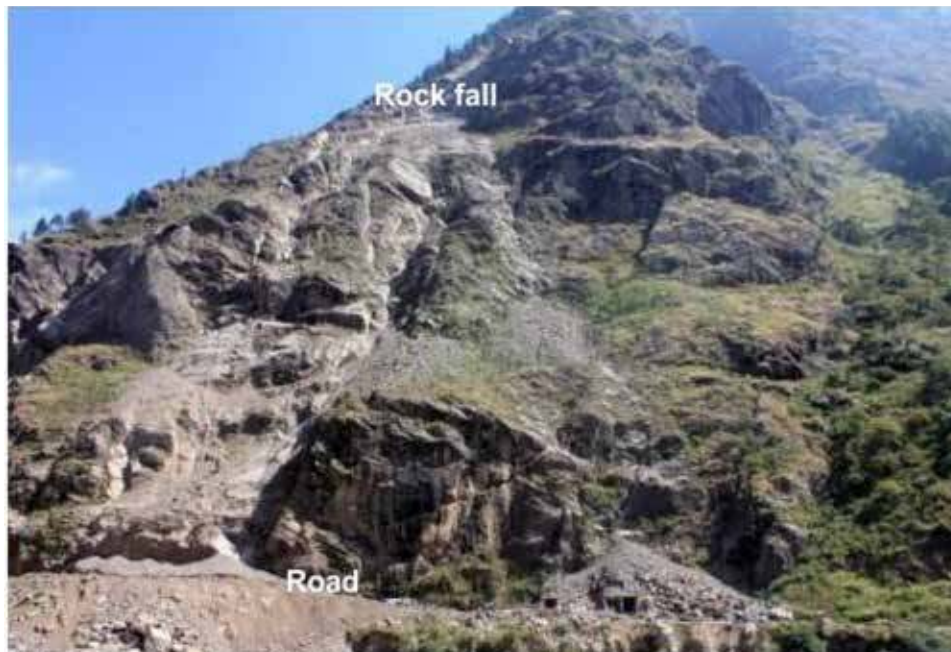
Figure 16: Massive rock fall near Friendship Bridge of Rasuwa Gadhi. View to NE

the Bhote Koshi River (Figure 16), near the Friendship Bridge, more than 300 m high and about 50 to 100 m wide rock fall destroyed many office and residential buildings. The fall killed about 30 people and also blocked the road to Rasuwa Gadhi for several months.

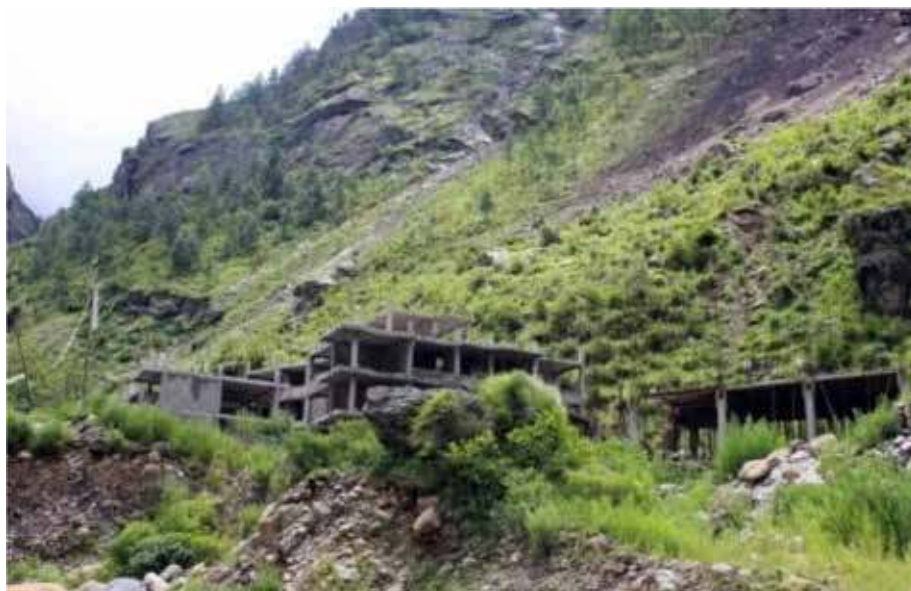
*Figure 17: Buildings of Rasuwa Gadhi Hydropower Project damaged by rock fall. View to E*

The office building site of the Rasuwa Gadhi Hydropower Project is located on the left bank of the Ghatte Khola and the Bhote Koshi River. It stretches along the foothill of a large rock cliff with talus cones (Figure 17). This area suffered from severe rockslides and rock falls, which significantly damaged the five buildings under construction. Many large boulders and debris came down from about 400 m high cliff. Much of the material also came down when a series of rainfall events hit the area. The boulders destroyed roofs, columns, and the ground floors of the buildings.

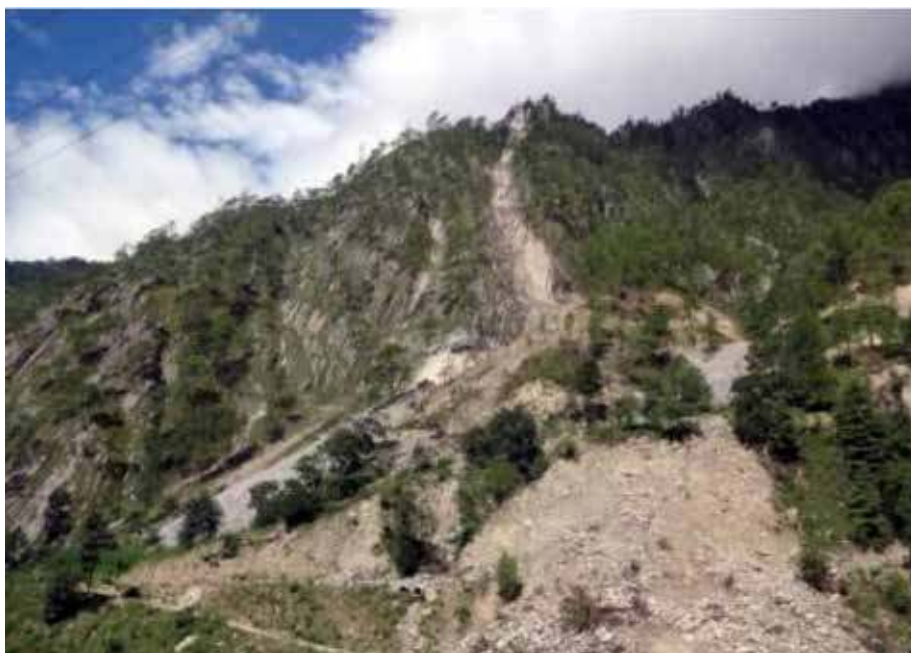
*Figure 18: Rock fall near valve chamber and damaged road at Rasuwa Gadhi. View to SW*

The earthen road leading to the two portals of valve chamber and access tunnel was severely affected by the earthquake and rainfall. The two portals are located within the rock fall zone from about 150 to 200 m above a rock cliff and gully (Figure 18).

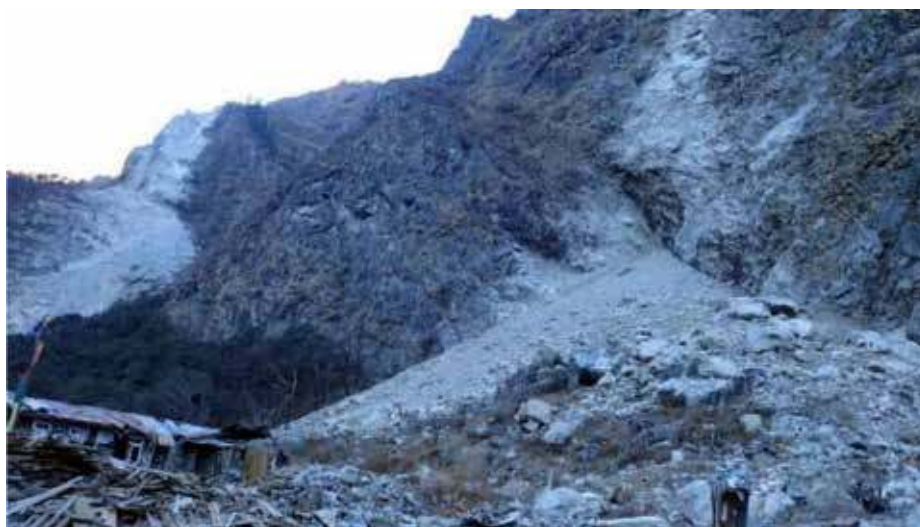
*Figure 19: Rock fall at Ghodatabela in Langtang Valley*

The beautiful Langtang Valley, lying at an altitude of about 3400 m, is the third most popular trekking destination in Nepal. At Ghodatabela, at an altitude of about 3011 m, rock falls and slides are very common. The area lies in a high hazard zone (Figure 19). In the Lama Hotel area, the rock falls have also affected the main building, causing loss of both human life and property.

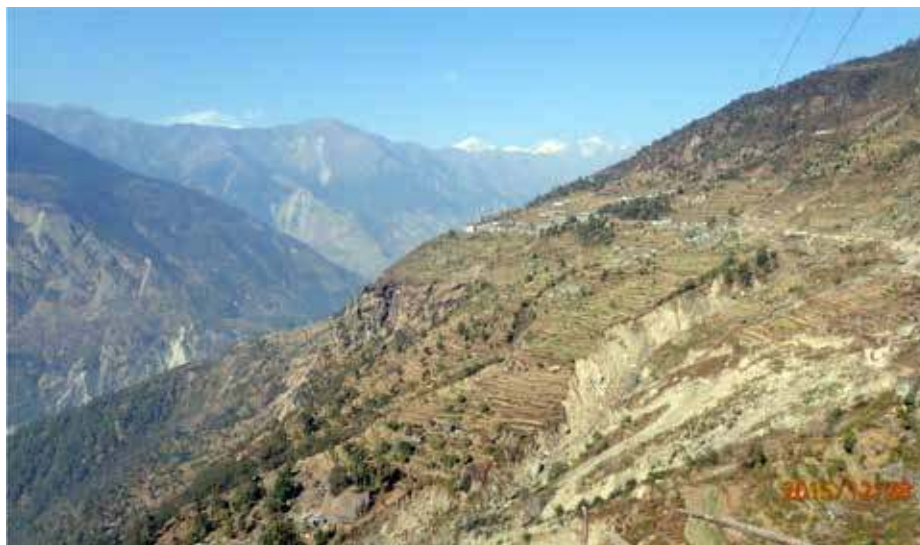
*Figure 20: Actively moving deep-seated landslide at Ramche. View to N*

are present in the cultivated land in the vicinity of the gully, where erosion is intense. The actively moving, deep-seated, very large old slides at Grang, Mulkharka, and Ramche were not badly affected by the earthquake (Figure 20).

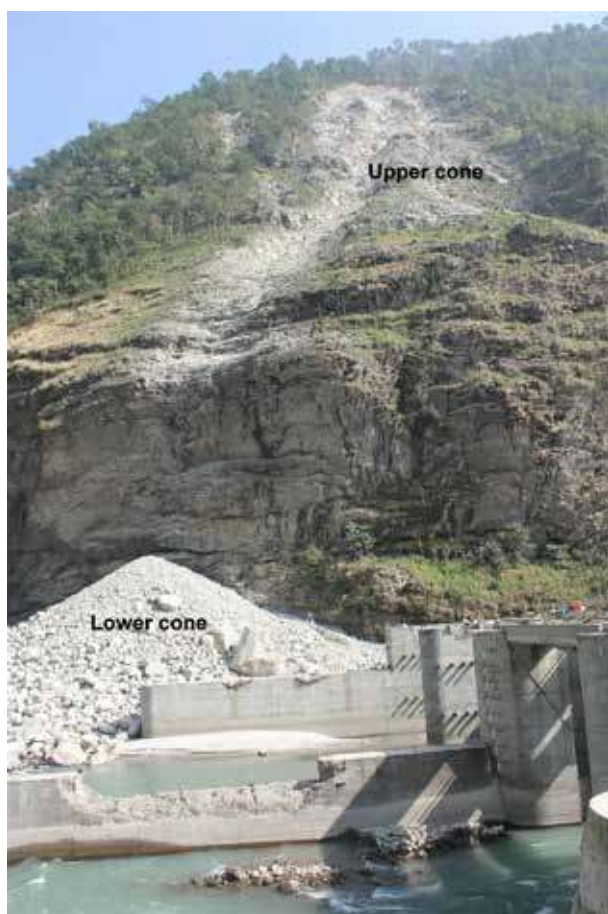
Figure 22: About 150 m high rockslide–rock fall with a large talus cone on left bank of Trishuli River. View to E

confluence was devastated by rockslides, debris slides, and rock falls (Figure 21). At the weir of Trishuli 3A Hydroelectric Project, on the left bank, two debris cones, about 30 m wide and about 10 m high (upper) and about 15 m wide and 7 m high are positioned. The material comes down from about 100 to 150 m above

the riverbed (Figure 22) causing rock fall mainly in the monsoon period.

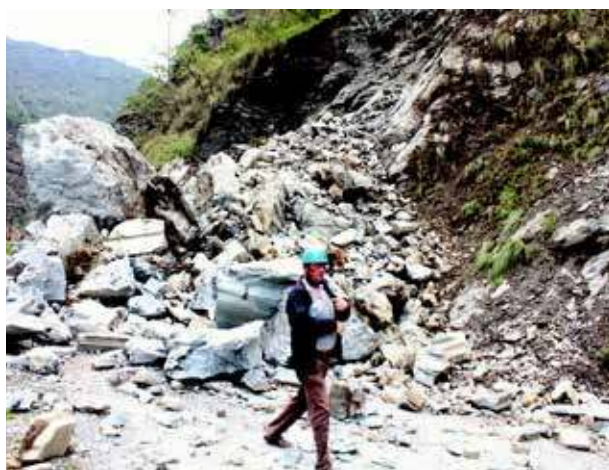
Figure 27: Wedge rockslide with large boulders, blocking Arniko Highway. It was triggered by first heavy monsoon rain after earthquake. View to NW

A large wedge slide (Figure 27) occurs on the Arniko Highway, about 2 km south of the Last Resort. The failed zone is about 30 m wide and 10 m high. Many boulders, soil, and tree branches block the highway. This failure was triggered by the heavy rain after the earthquake.

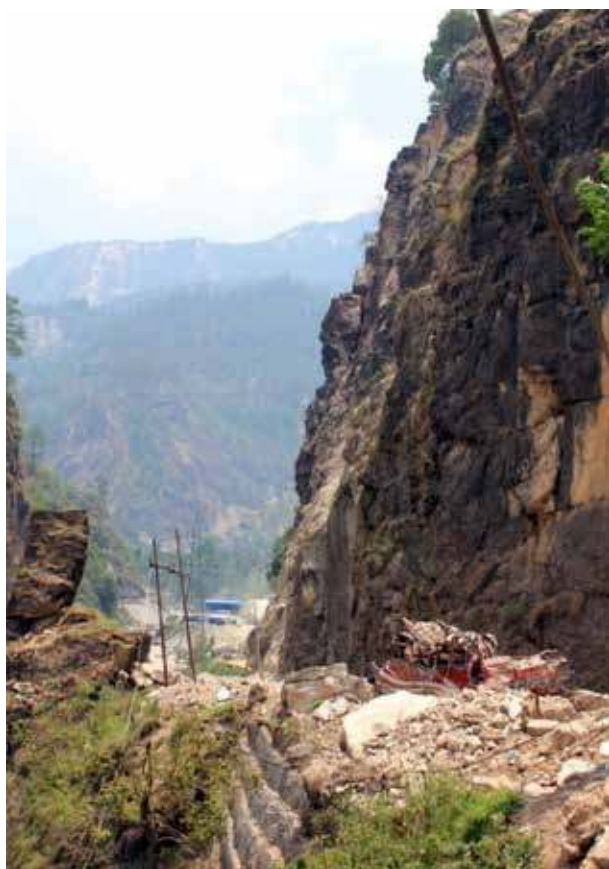
Figure 28: Unstable rock cliff with vertical joints near Chaku, where rock falls destroyed a vehicle. View to N

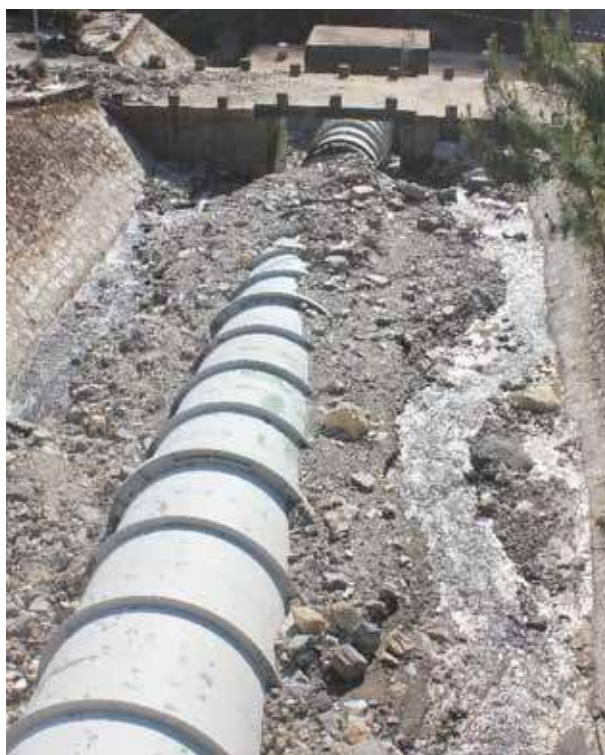
Figure 34: Damaged penstock pipe of Upper Bhote Koshi powerhouse. View to W

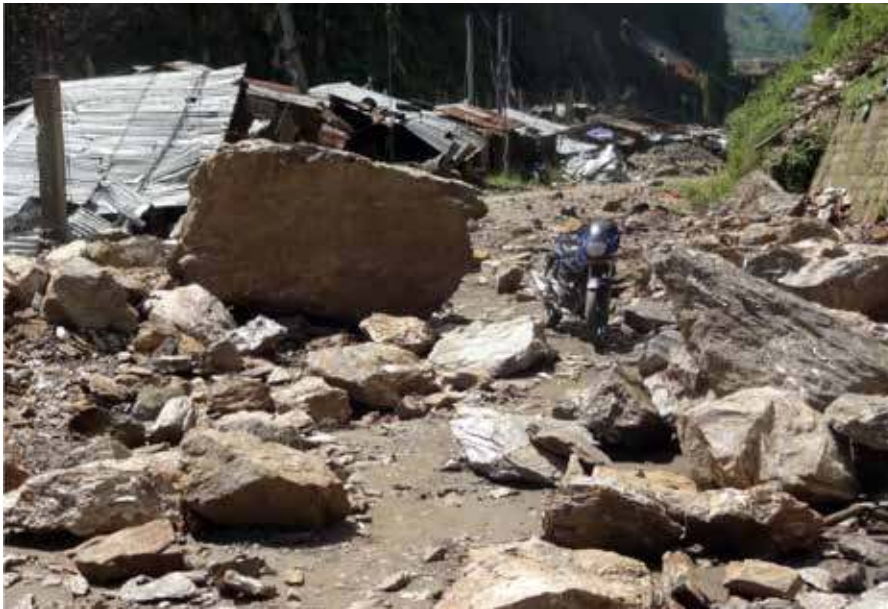
Figure 35: Failed rock blocks at Larcha, damaging settlement and road. View to S

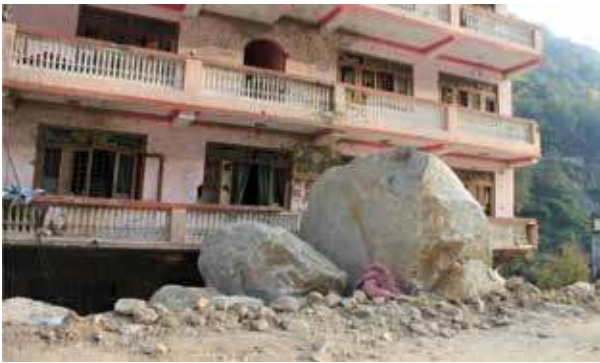
*Figure 37: Many large boulders and debris flow splash on buildings of Liping. View to E*

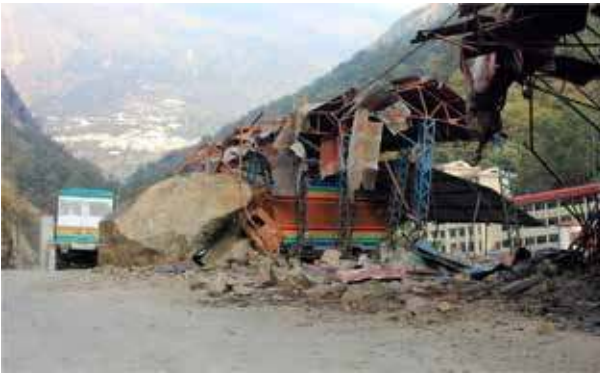
*Figure 38: Liping devastated by large boulder falls. Khasa (Jhangjhangmu) in China is seen in the background. View to N*

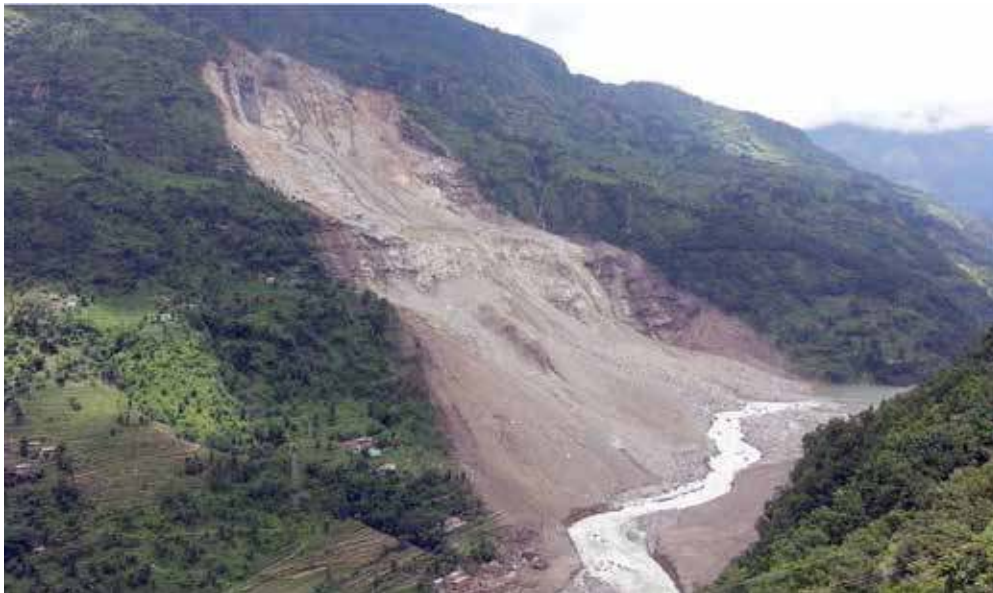
Figure 52: Jure rock avalanche on Arniko Highway. View to N

The Jure rock avalanche (Figure 52) occurred on 2 August 2014, on the right bank of Bhote Koshi River and destroyed about 1 km of the Arniko Highway. The disaster started about 800 m above the riverbed, from where huge rock masses travelling at a speed of about 60–70 km/sec crashed on the Arniko Highway. The avalanche is about 1500 m long, more than 500 m wide, and about 25 m deep. It created a landslide dammed lake (about 30 m deep, 450 m wide, and 3

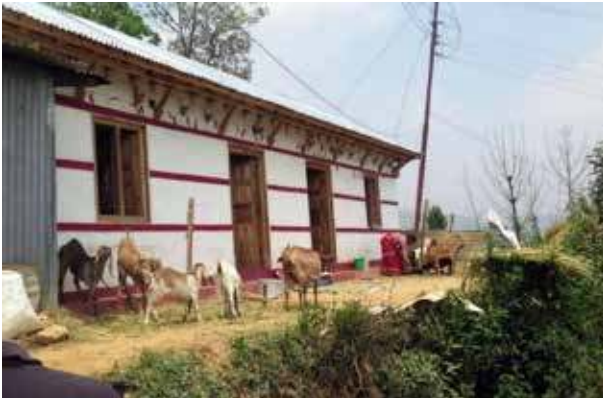
Picture 5: Model house constructed by Caritas Nepal for two widows. Location: Balthali, Panauti -11, Kavrepalanchowk. Photo: Caritas Nepal

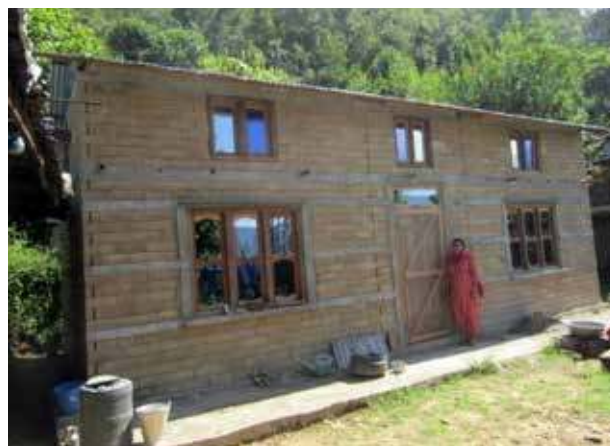
Picture 6: Durga Devi in front of her CSEB house in Thokarpa, Sunkoshi.

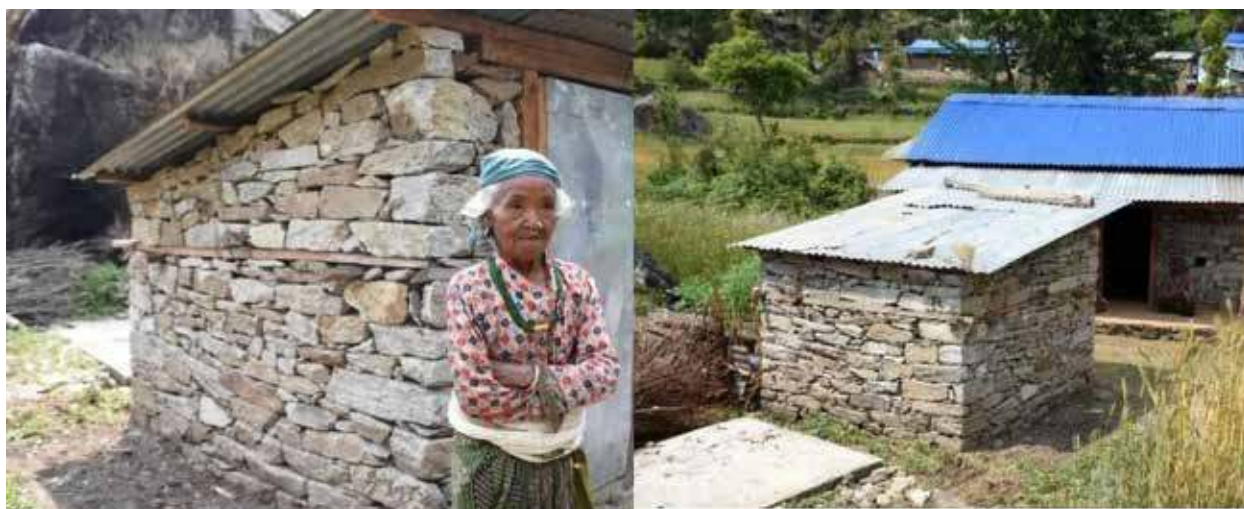
Pictures 7 & 8: An elderly lady living all by herself has constructed a house and a toilet with septic tank, Bulung Bigu-3, Dolakha. Photo by: Caritas Nepal

few households without toilets used those of neighbors. A survey in six locations of Dolakha, Sindhupalchowk, and Kavrepalanchowk had said open defecation had increased after the earthquake had damaged more than 93 percent toilets in the villages (Kumar, 2015). The toilets were constructed next to the reconstructed houses. Many had a separate room with a pan and an external septic tank, while others had room with a pit toilet.

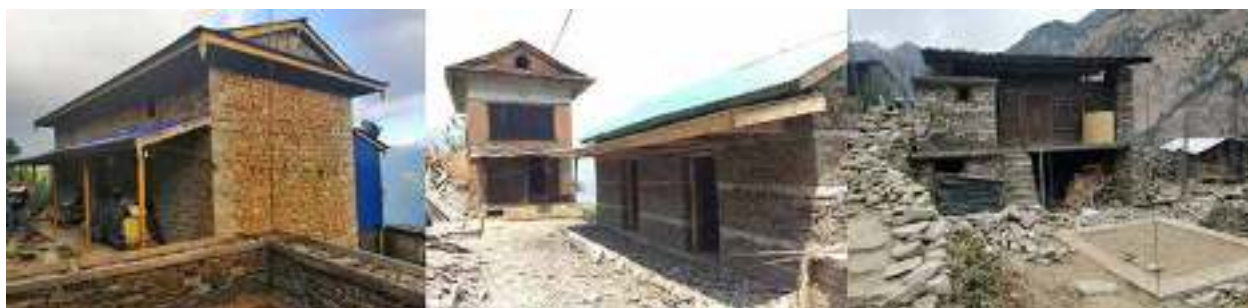
Figure 1. The earthquake resilient small houses built in front of old damaged houses (Photo Credit BBC Media Action and DFID Nepal)

as shown in the leftmost picture of Figure 1. Similarly, in Khiji Chandeshwari, Okhaldhunga, the homeowner had built a new house which has only a kitchen and one bedroom (on the right-hand side of middle photo). The family had continued using the damaged house (on the left-hand side of the middle photo) to store grains and belongings because the new one was not big enough.

In Gatlang, Rasuwa, new one-roomed structures were being constructed to access the Government of Nepal (GoN) housing reconstruction grant. But the traditional houses, mostly reconstructed in 2015, did not comply with the building code and technical requirements under the grant process (NRA, 2017). Therefore, investment is required in research and testing to develop relevant corrections/ retrofitting measures so that the new traditional houses can be strengthened to reduce risk from future earthquakes (see: right most photo of Figure 1).

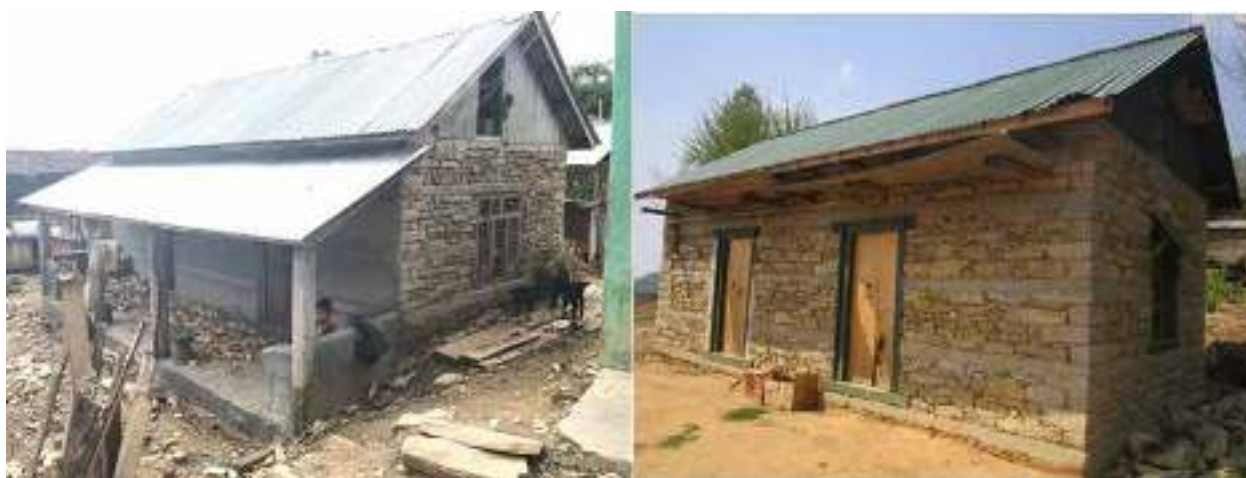
Figure 9: Left: demonstration house in Aru Pokhari, Gorkha supported by an INGO working in the area. Right: a house constructed as part of on-the-job training for masons in Kavrepalanchok supported by an INGO. Source: HRRP, 2020

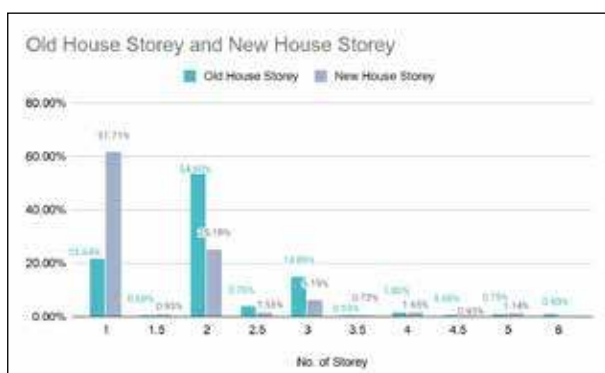
Figure 12: Comparison number of stories built before and after the earthquake (%).

Comparatively, more single-story houses have been built after the earthquake. As seen in figure 12, two story houses were more prevalent (54.4 percent) before the earthquake, which decreased after the earthquake (25 percent).

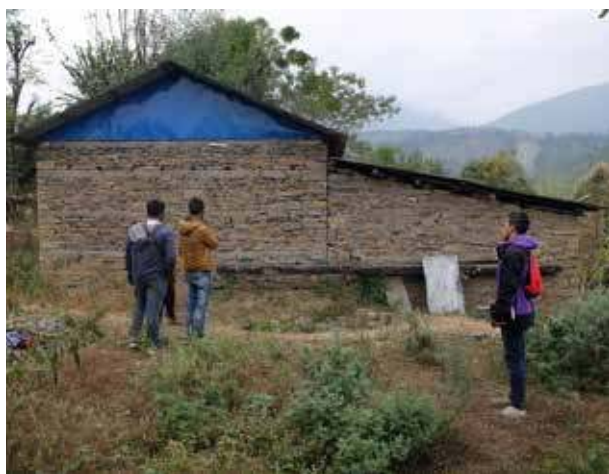
Figure 19.1: ASF-Nepal, SMM: Extension with earthquake resilient elements after receiving third tranche.

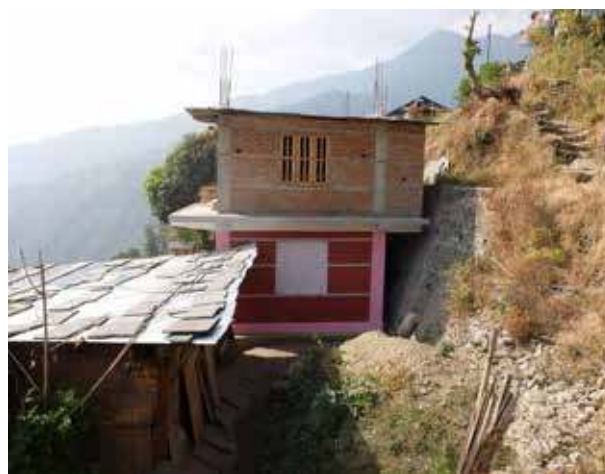
Figure 19.2: ASF-Nepal, RCC house: Extension after receiving a third tranche.

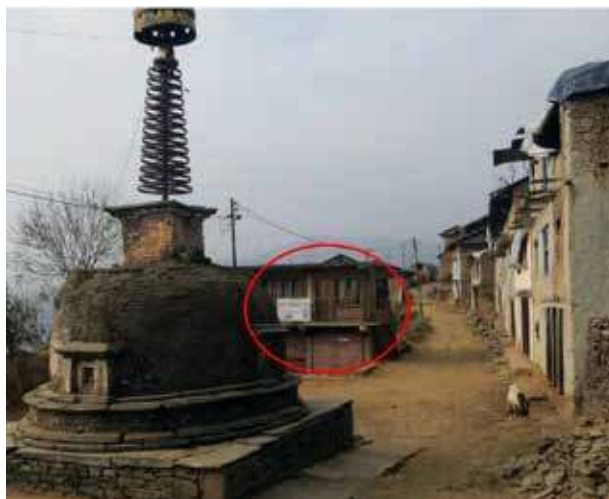
*Picture 1: Vernacular Newari architecture of Dwalkha threatened by modernization*

residential. Of 338 houses, 168 had been newly built within a period of 10 years (2005-2015) and around 50 percent of the total houses were more than 50 years old. The vernacular Newari architecture predominated the built-up area, and this fact highlighted the importance of conservation of vernacular architecture to be considered in the urban regeneration plan. The few reinforced concrete constructions already threatened conservation of the architecture of the settlement as highlighted in the picture 1 above.

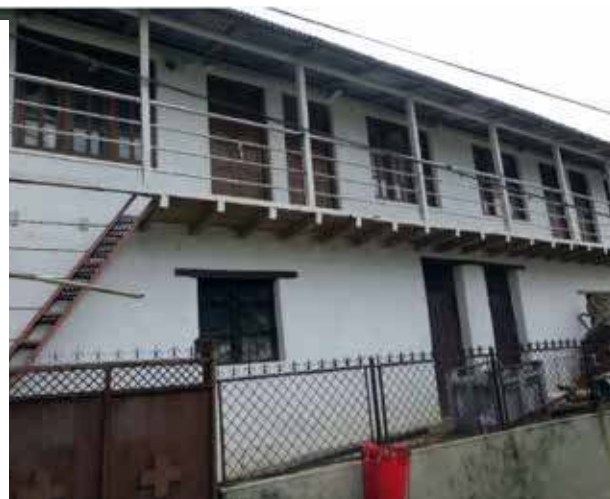
*Picture 2: Reconstruction of a house after the 2015 earthquake*

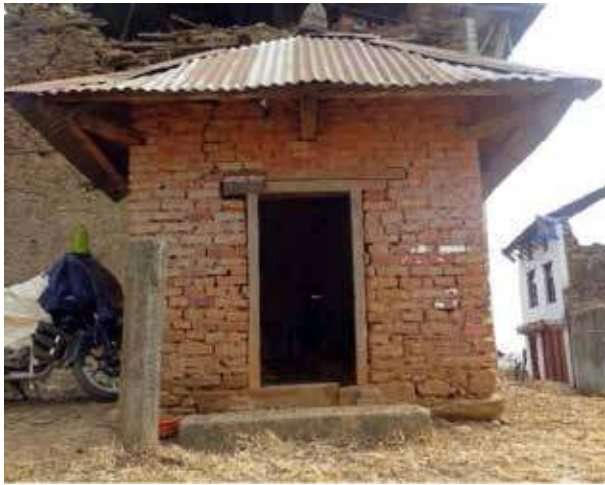
Picture 3: Narayan Temple after Gorkha Earthquake 2015

modern RCC buildings in Dwalkha showed that some locals lacked a concept of conserving their settlement as a heritage settlement. Meanwhile, the municipality was aware about Dwalkha losing its vernacular architectural forms but had not made strict rules and regulations to stop the unplanned construction of RCC buildings and reconstruction of temples. The reconstruction of few temples had not followed conservation practices, an issue that was addressed in the regeneration plan, which, however, remained to be implemented. Pictures above (3, 4, 5, and 6) show Narayan temple and Pashupati temple immediately after the earthquake 2015 and after reconstruction.

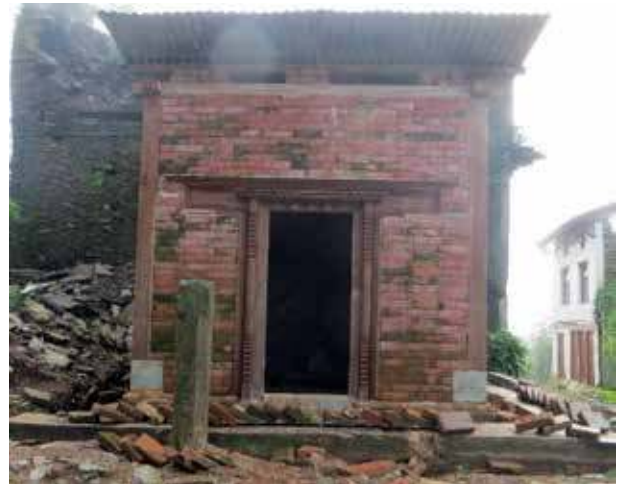
Picture 4: Narayan Temple after reconstruction

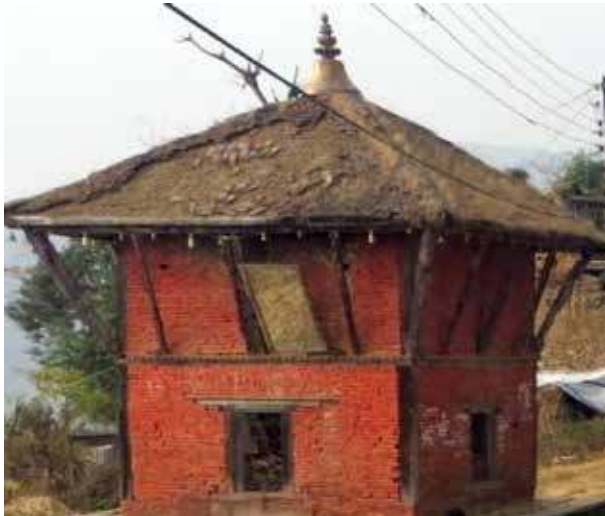
Picture 5: Pashupati Temple after Gorkha Earthquake 2015

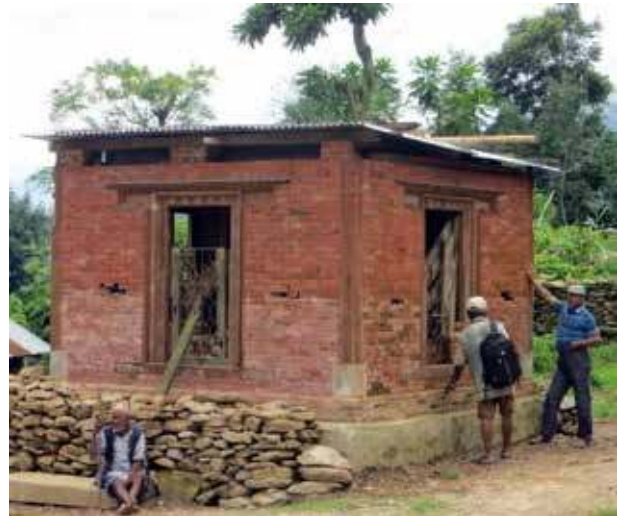
Picture 6: Re-constructed Pashupati Temple

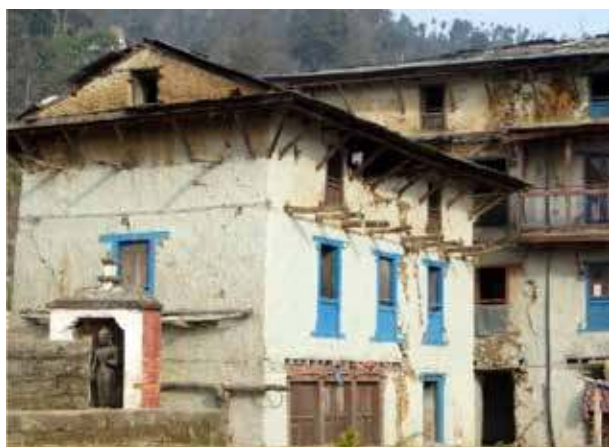
Picture 7: Houses damaged by 2015 earthquake

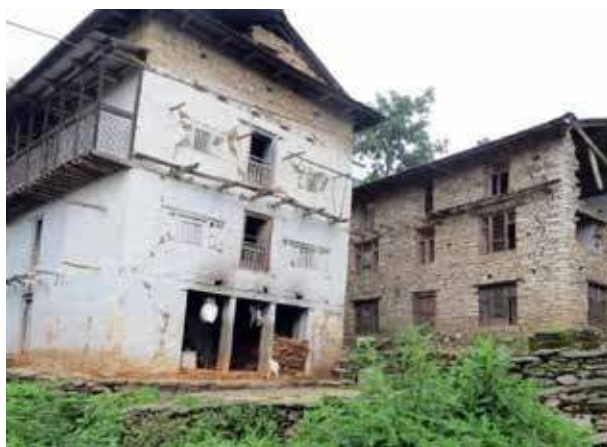
Picture 8: Houses damaged by 2015 earthquake

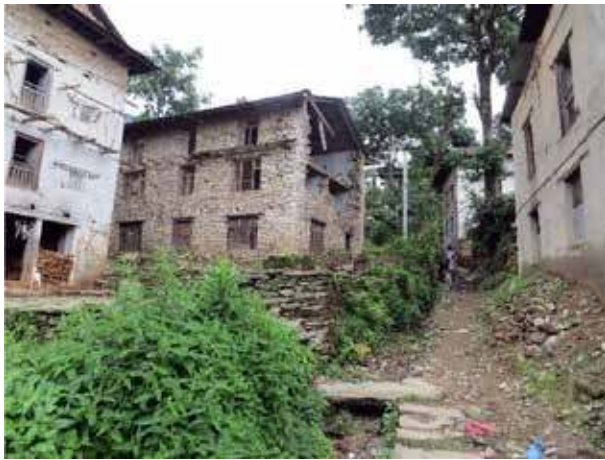
Picture 9: Vernacular buildings of Dwalkha damaged by the earthquake

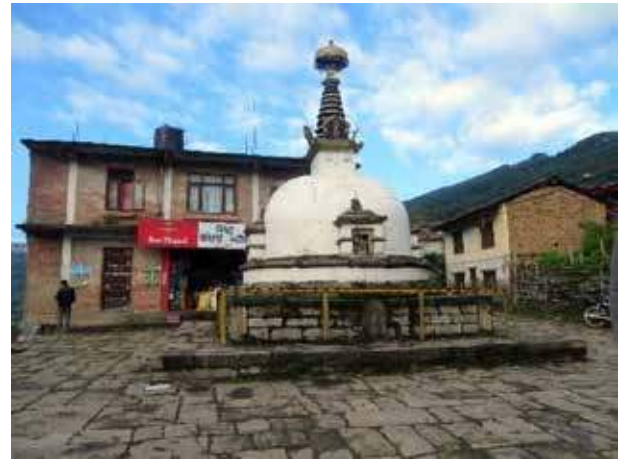
Picture 10: Vernacular essence being engulfed by RCC construction

**Architectural trend:** Another factor was modernization that was competing with vernacular architecture (Picture 10). As also noticed by Chan and Boussa, modernization was prioritized at the cost of cultural heritage. There is a desire among some people to modernize the settlement with wider roads, more commercial buildings and change the land use to convert the settlement into a commercial center. Therefore, there is an urgent need to not only support the people who have lost their houses in the earthquake to build back better, but also to raise awareness regarding the values and associated benefits historic settlement have. There is an urgent need to provide residents with necessary support to build their communities and make them prosperous while conserving the vernacular architecture and cultural heritage sites, and building livable and safer settlements.
